# ECHELON ENGINEERING, INC.

## SUBSTRUCTURE INVESTIGATION, TESTING & ASSESSMENT OF BASCULE PIERS

16 th AVENUE SOUTH BRIDGE  
Seattle, Washington

September 1994  
J93-1025

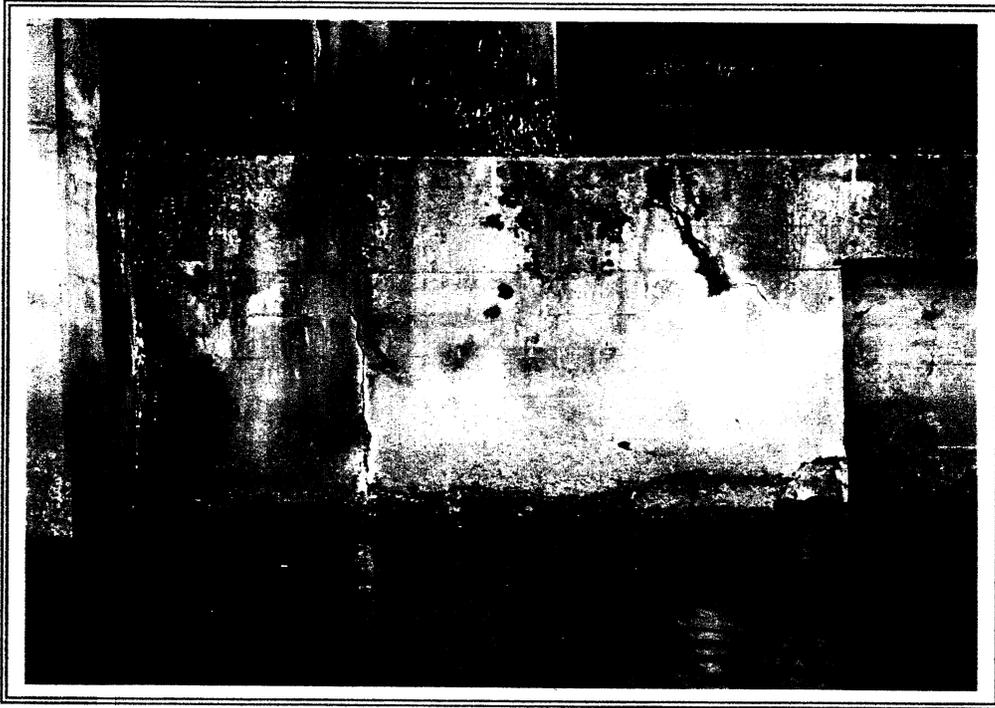
PHOTO 4: North Bascule, North Face - Note the large vertical and diagonal cracks located between STA 0+05.1 and STA 0+14.8, respectively. Also note the horizontal crack at the waterline, as well as the hairline cracking and efflorescence.

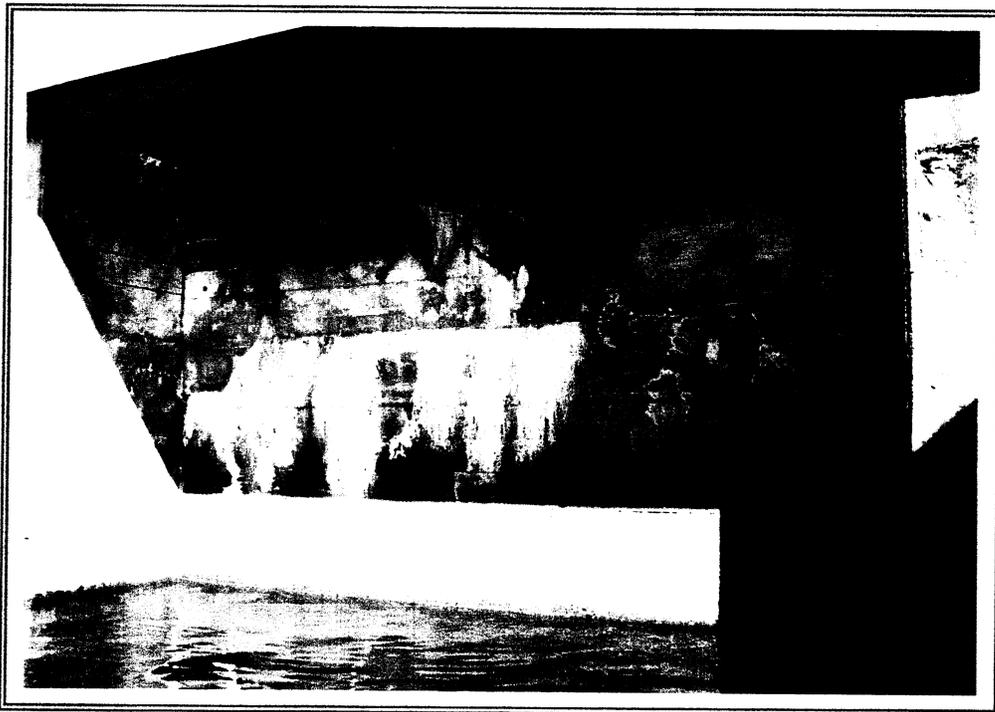
PHOTO 5: North Bascule, East Face - Extensive hairline cracking with efflorescence, located between STA 0+12.4 and 0+26.6.

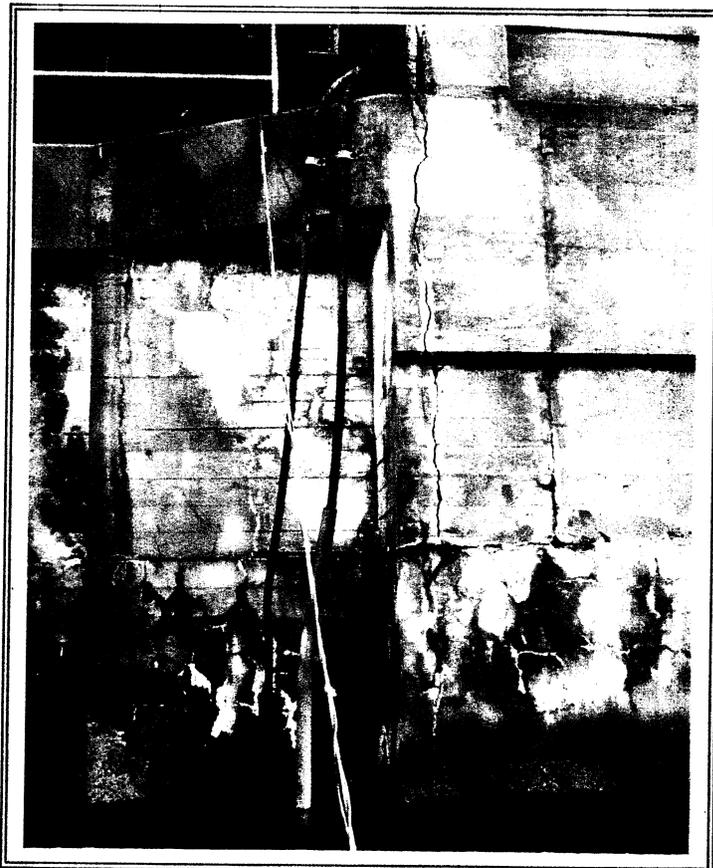
areas above El. -3.0 exhibit heavy hairline cracking and efflorescence. Additionally, numerous locations have sustained significant horizontal and/or vertical cracking. The North and South faces exhibit the most severe cracking. In some areas these cracks are in excess of 1/2 inch in width and over 4 inches in depth. Significant cracking was found in the vicinity of the bridge bearings. Many of the cracks in these locations penetrate from the exterior face through to the Interior Pit. (Refer to Appendix A, photos 7, 8 and 10).

PHOTO 7: North Bascule, South Face -  
Extensive vertical cracking  
between STA 0+40 & 0+50.  
Also note the hairline  
cracking with efflorescence.

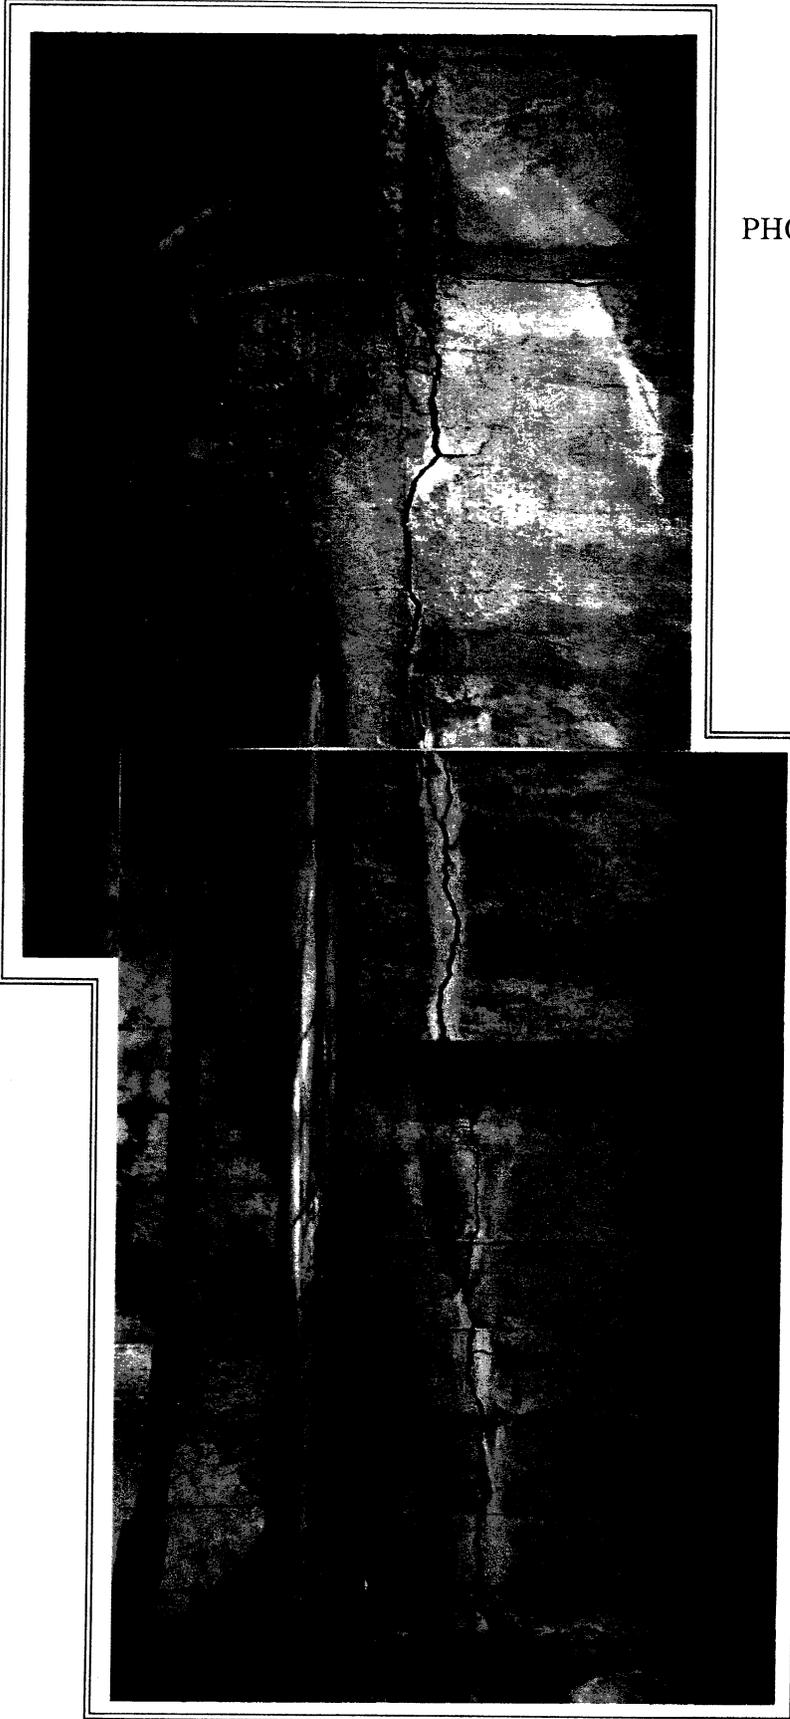
PHOTO 8: North Bascule, South Face -  
Severe vertical cracking at  
STA 0+46, this crack  
exceeds 4" inches in depth  
and continues through the  
pier and into the  
interior pit.

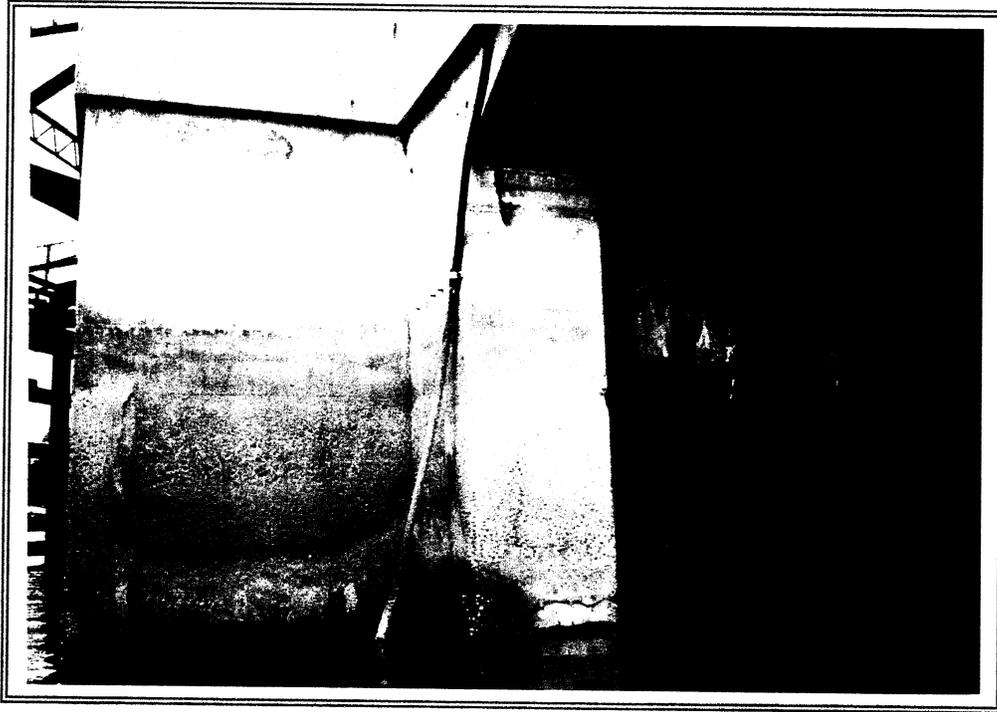
PHOTO 9: North Bascule, East Face - Note the corner spalling and delamination of corner repair/patches near the waterline. Also note the hairline cracking and efflorescence along the right side of the photo.

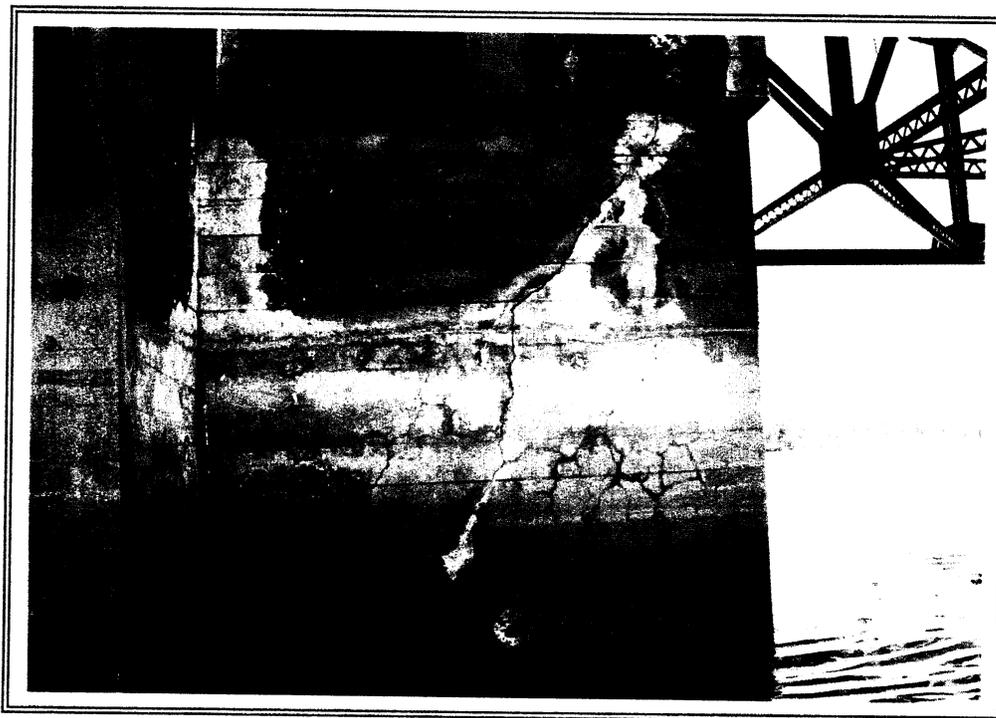
PHOTO 10: North Bascule, East Face - Diagonal and hairline cracking along the east-west wall at STA 0+35 to 0+39.

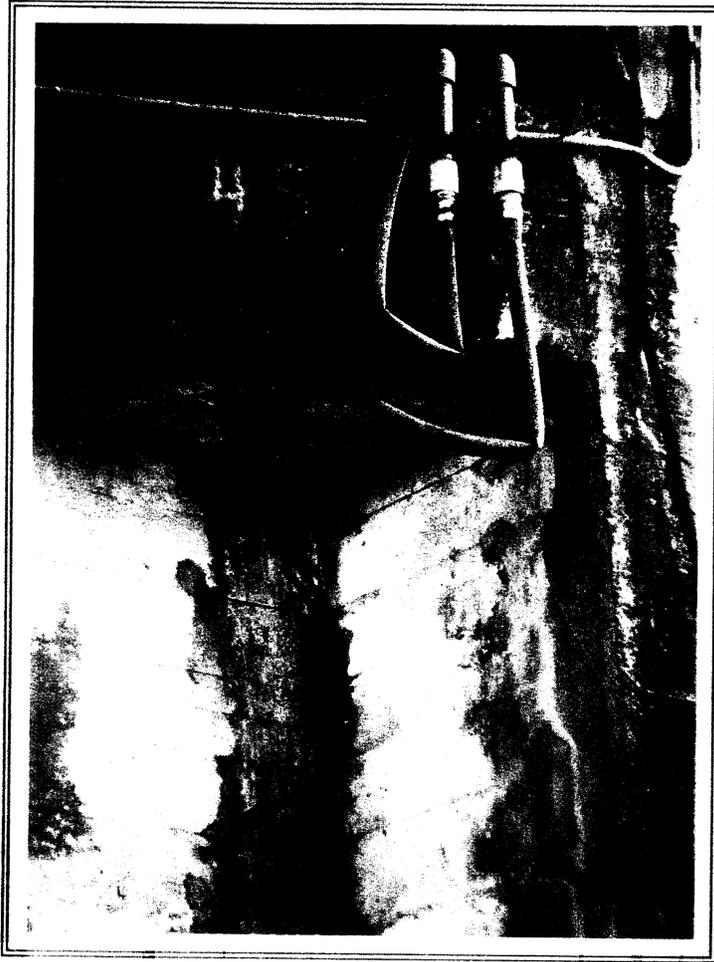
7. Cracking was noted in the North and South faces of the Pier, located in the vicinity of the bridge bearings for both the fixed and moveable portions of the structure. These cracks were found to vary in length, and to range from 1/4" to 1/2" in width, and greater than 3 inches in depth when probed with a slender wire. (Refer to Appendix A, photo 13).

PHOTO 13: South Bascule, North Face - Severe vertical cracking at STA 0+45.8. This crack extends for 24' down the wall with a width of up to 3/4" and a depth in excess of 3 inches.

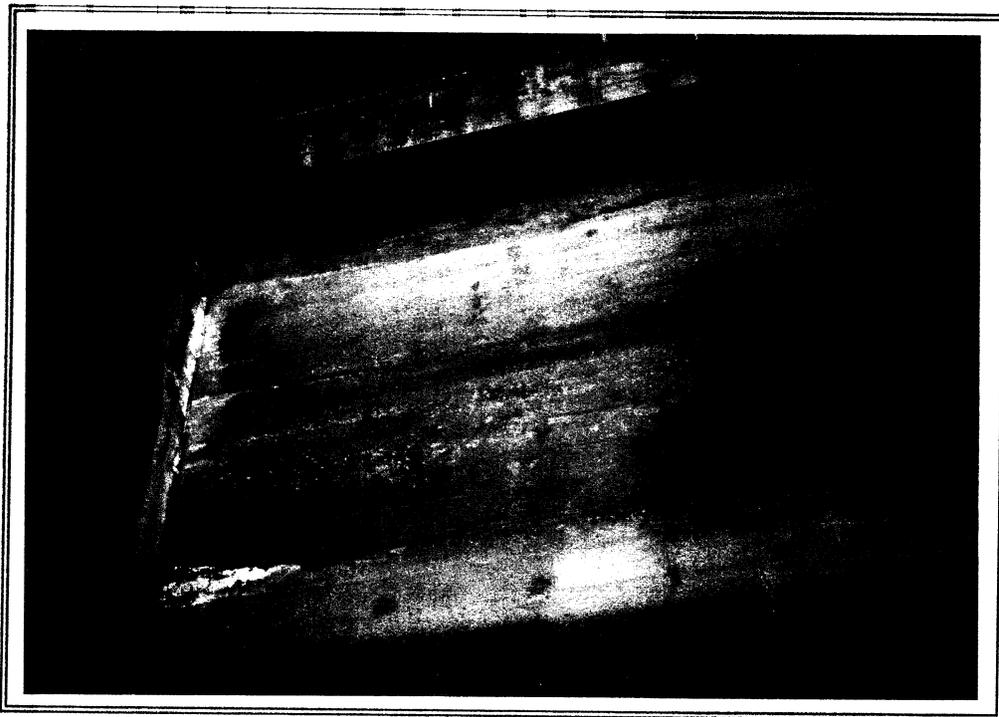
PHOTO 14: South Bascule, North Face - Vertical cracking down the length of the wall. Several vertical cracks are located along this face.

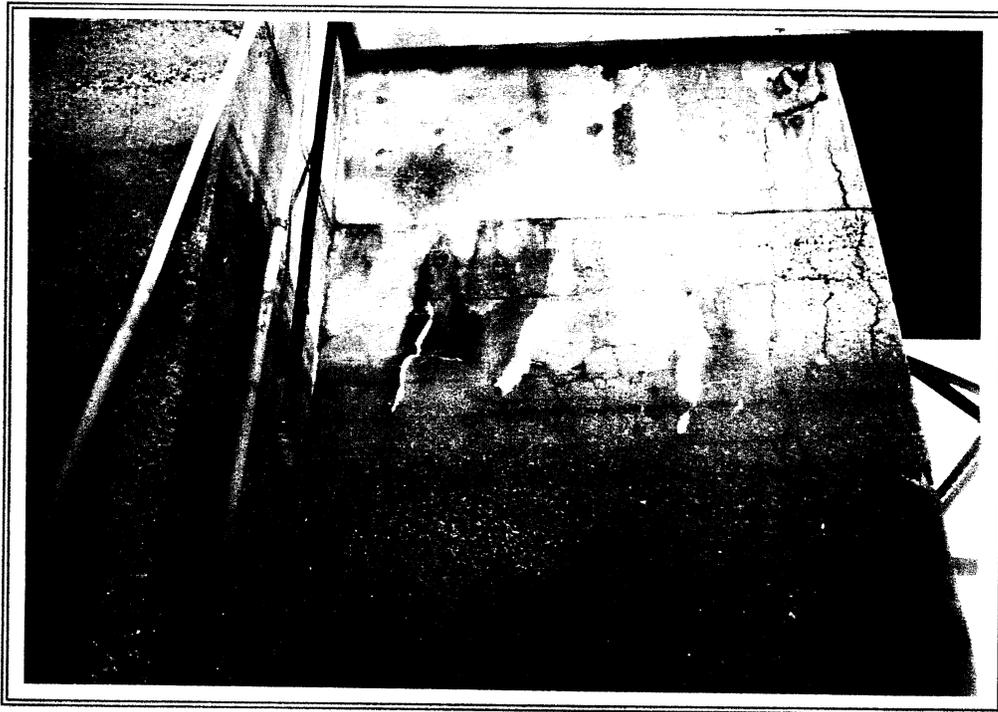
5. The damage to the upper elevations of the Pier, (above El. -10), included several vertical and horizontal cracks, as well as hairline cracking and efflorescence, indicating contamination of the concrete. (Refer to Appendix A, photos 15 and 17).

PHOTO 15: South Bascule, West Face - Typical cracking with efflorescence, (STA 0+30.3 to 0+39). Note the exposed and corroded reinforcing steel in the upper right corner.

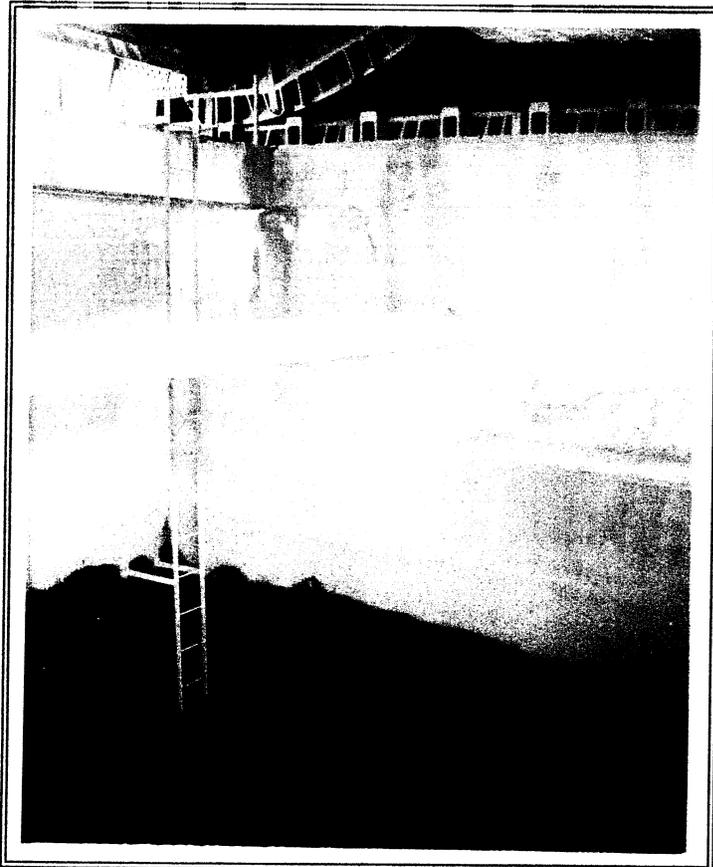
PHOTO 24: South Bascule, East Face of Interior Pit - Note the extensive hairline cracking with efflorescence denoting contamination of the concrete.

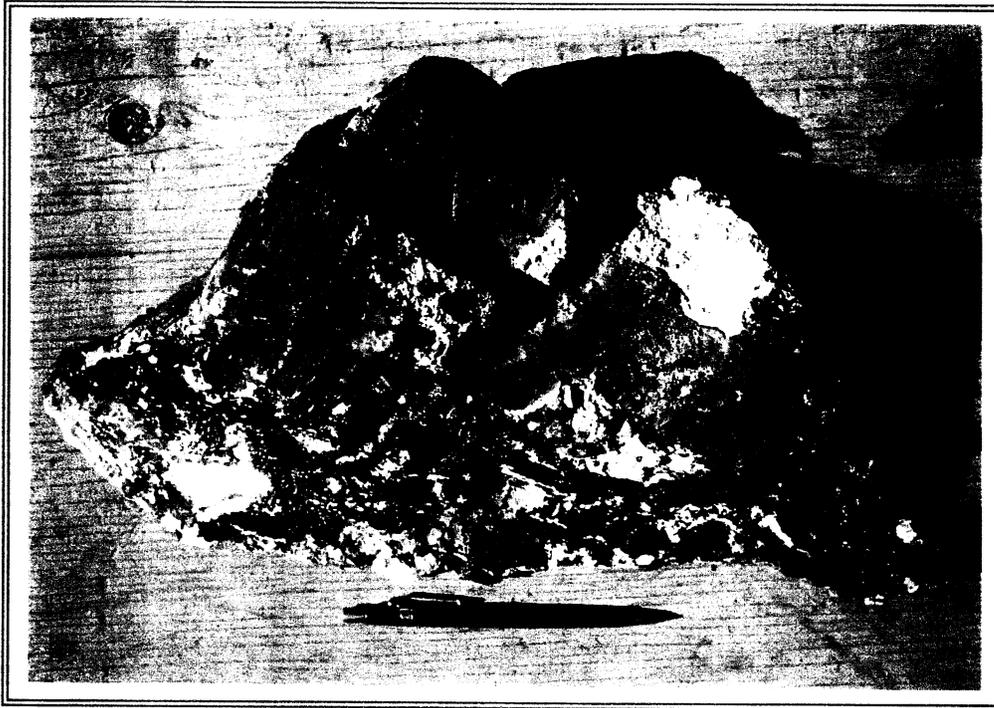
6. Below El. -10 the condition of the concrete surface is generally poor. Extensive areas of heavy spalling were found. The majority of these areas exhibit "punky" concrete, which is soft and were easily crumbled by the diver/inspector during the cleaning and inspection procedure. (Refer to Appendix A, photos 9, 11 and 12)
7. Large areas of spalling and cracking were found on all exterior faces of the Pier. However, the most extensive damage was found on the South and East faces of the structure. This damage included heavy corner spalling and exposed rebar, with large areas of concrete which literally "fell off" in chunks when touched, (Refer to Appendix A, photos 25 and 26). The concrete beneath these locations is also soft and easily crumbled.

PHOTO 25: Concrete Sample - Taken from the badly spalled, northeast corner of the North Bascule. Note the black and rust coloration of the material. The concrete is soft and brittle, and easily broken by hand.

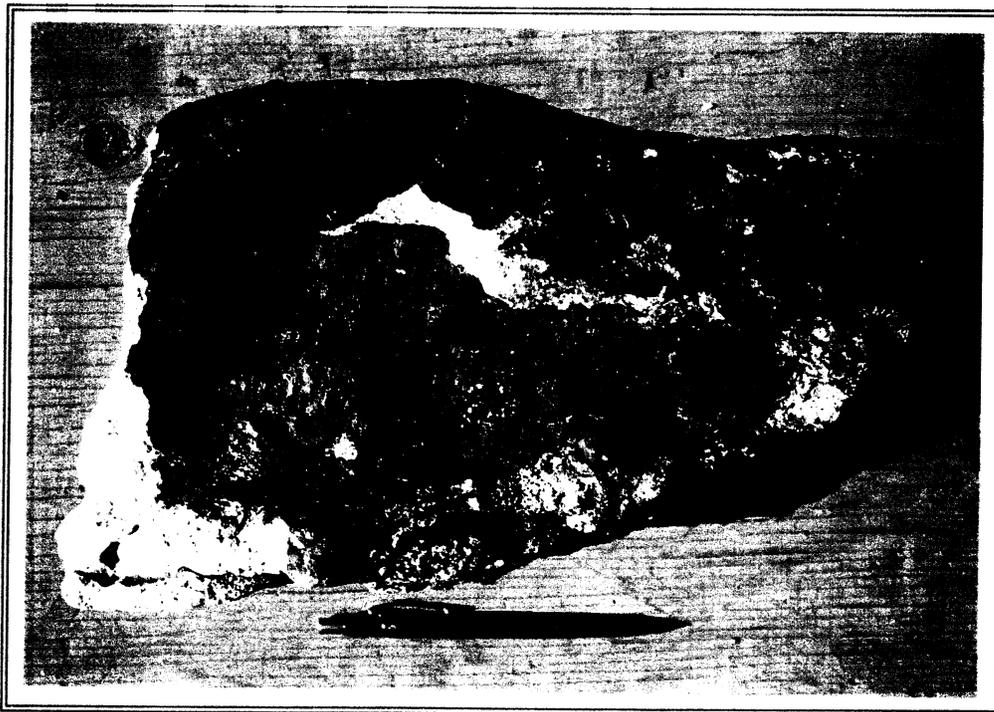
PHOTO 26: Concrete Sample - Taken from a badly spalled corner. Note the black and rust coloration of the material. The concrete is soft and brittle, and easily broken by hand.

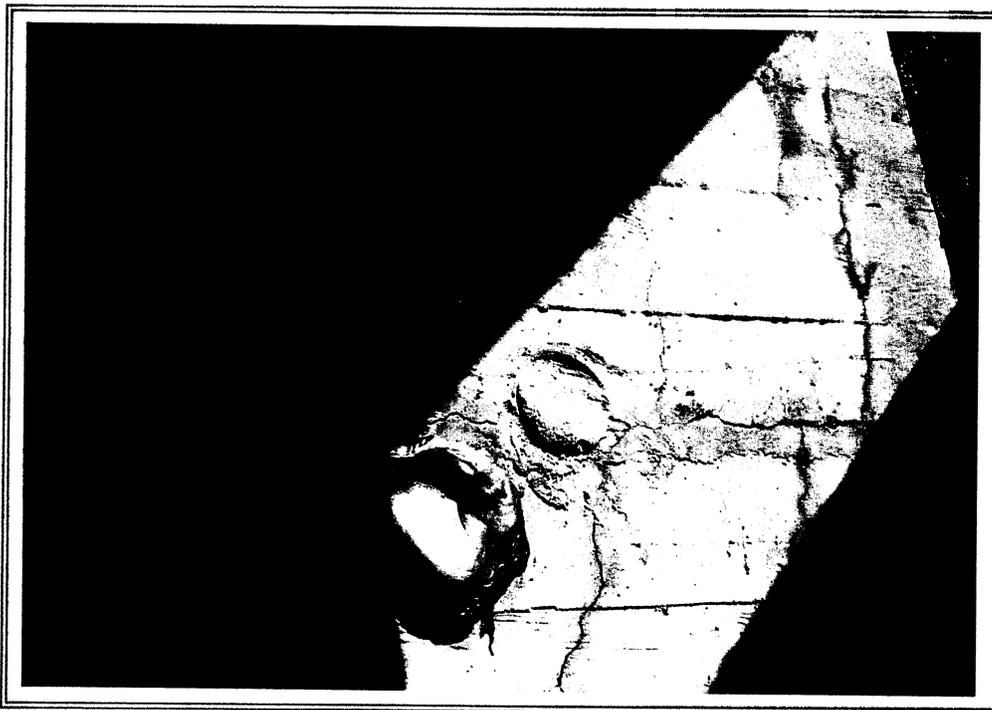
PHOTO 28: North Bascule, East Face - Core drill location, note the 1986 core location, (center right) and the adjacent core location of Sample #4, (center left).
