**Washington State  
Department of Transportation**

**UNDERWATER INSPECTION REPORT**

**SOUTH PARK BRIDGE - 14TH AVE. OVER THE DUWAMISH RIVER**

**BRIDGE NO. 3179**

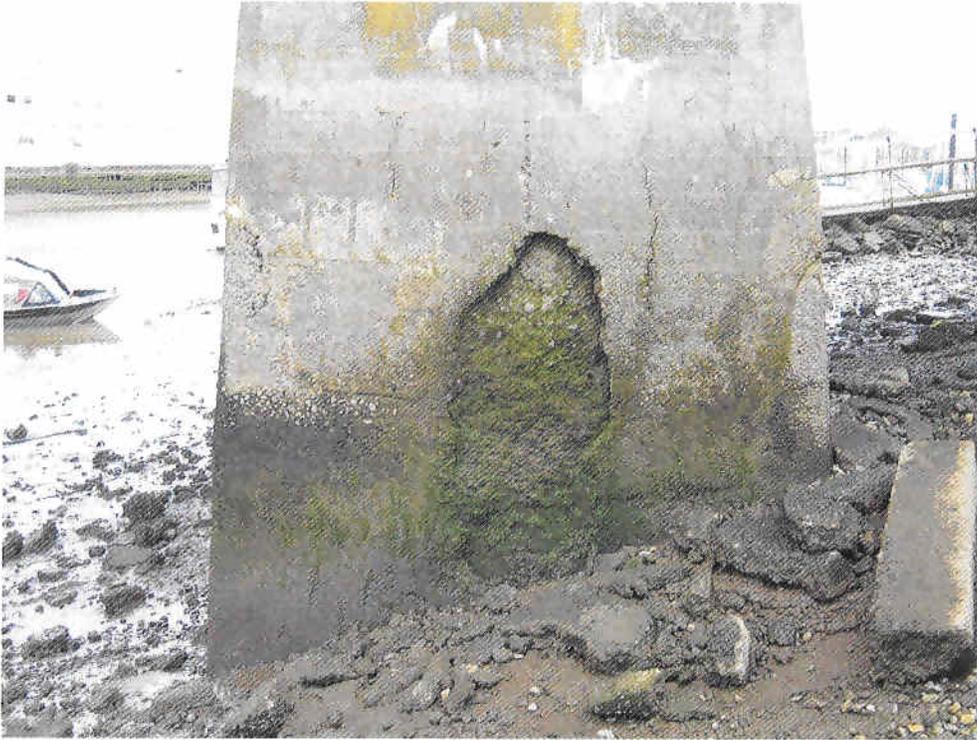
Specifically, the West face of Column A Pier 1 South has a 2-1/2' long x 1' wide x 2" deep area of section loss. The northeast corner of this same column has a 4' long delamination to the mudline and deteriorating concrete on the East face. On the East face of Column B Pier 1 South there is a 2' long x 1' wide x 2" deep spall at the mudline.

Photograph 1 : Concrete section loss on West face of Column A Pier 1 South.

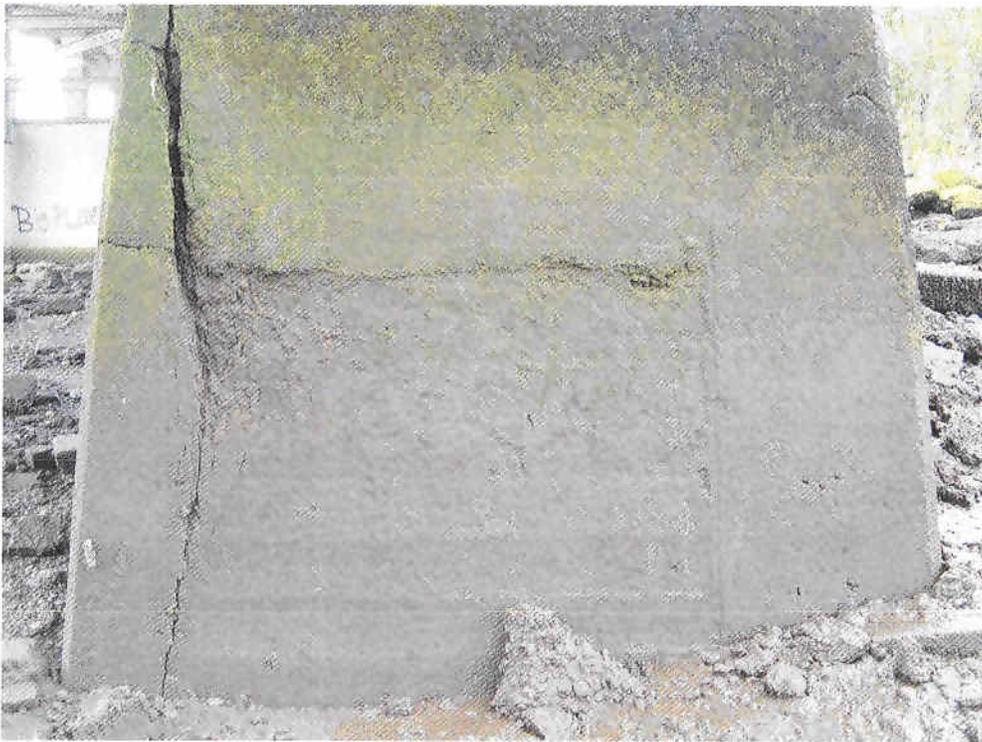
Photograph 2 : Delamination on northeast corner of Column A Pier 1 South. Note concrete abrasion at top of photo, typical on all substructure components in the intertidal zone.

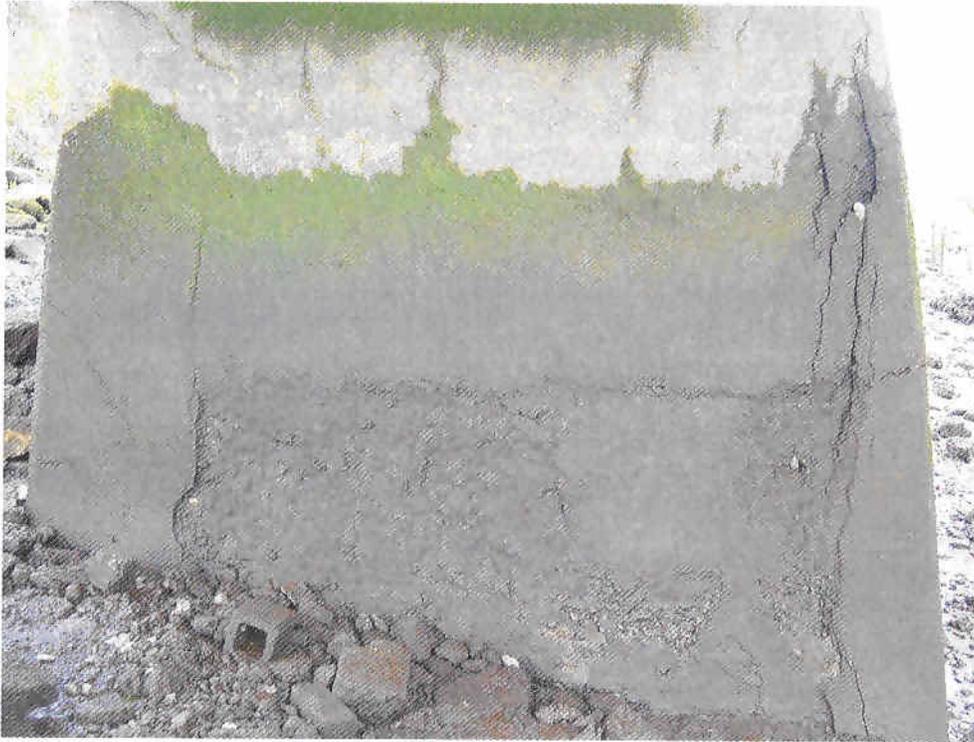
Photograph 3 : Deteriorating concrete on East face of Column A Pier 1 South.

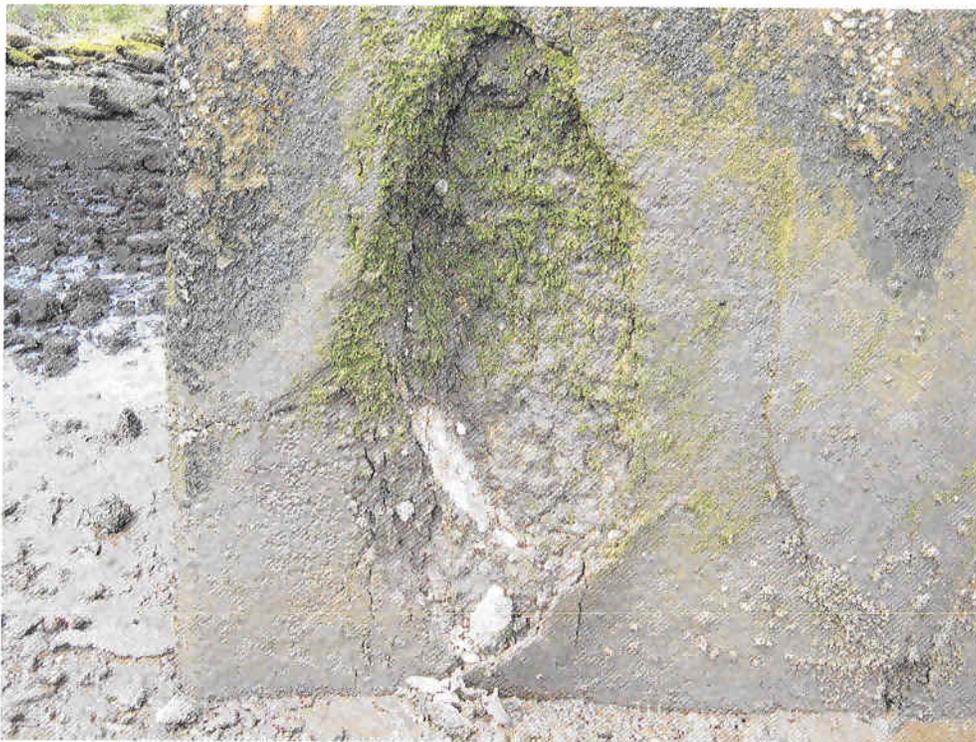
Photograph 4 : East face of Column B Pier 1 South: 2' long x 1' wide x 2" deep spall.

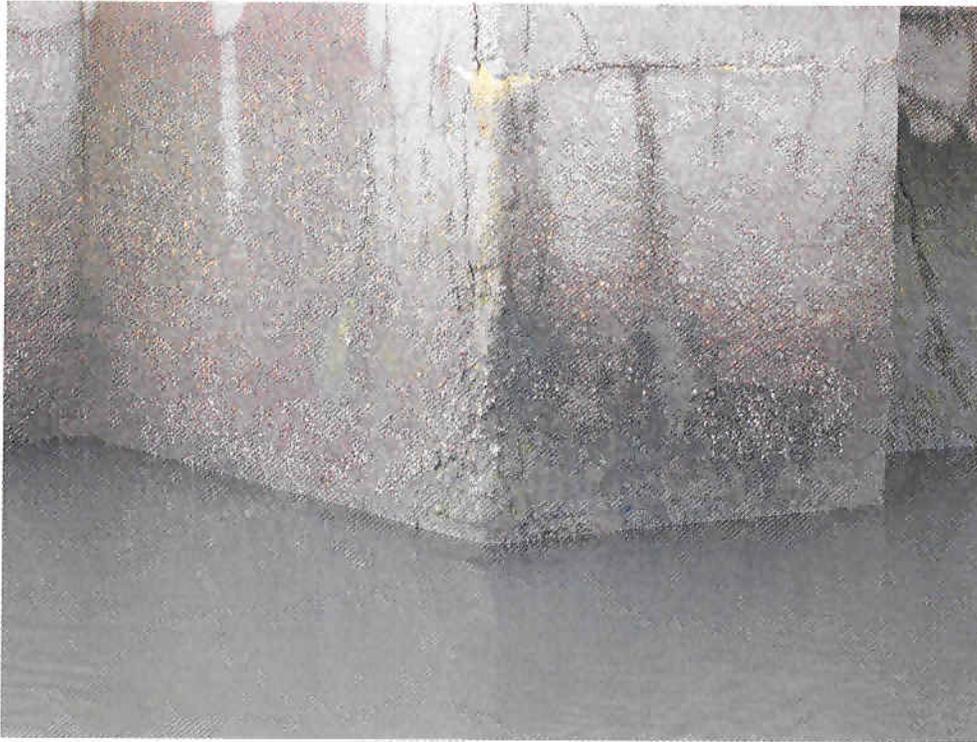
Photograph 5 : Southwest corner of South Bascule Pier. Note corner delamination, transverse leaching cracks, and abrasion.

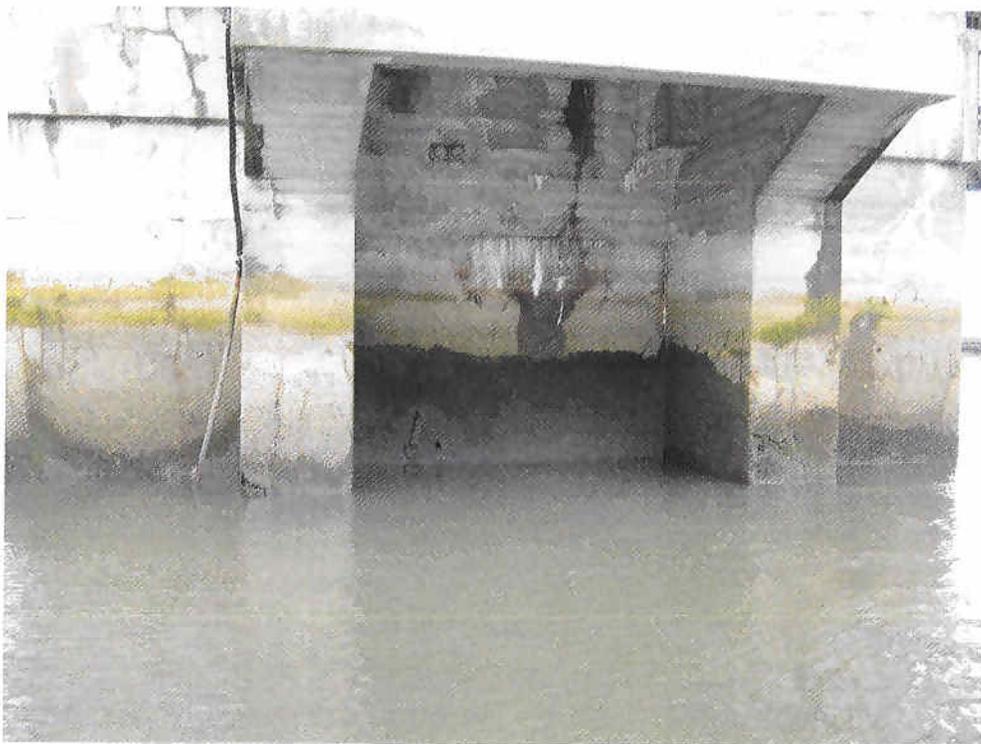
Photograph 6 : East face of North Bascule Pier abrasion in intertidal zone, spalling concrete at corners of tower, longitudinal cracks, and transverse leaching cracks.

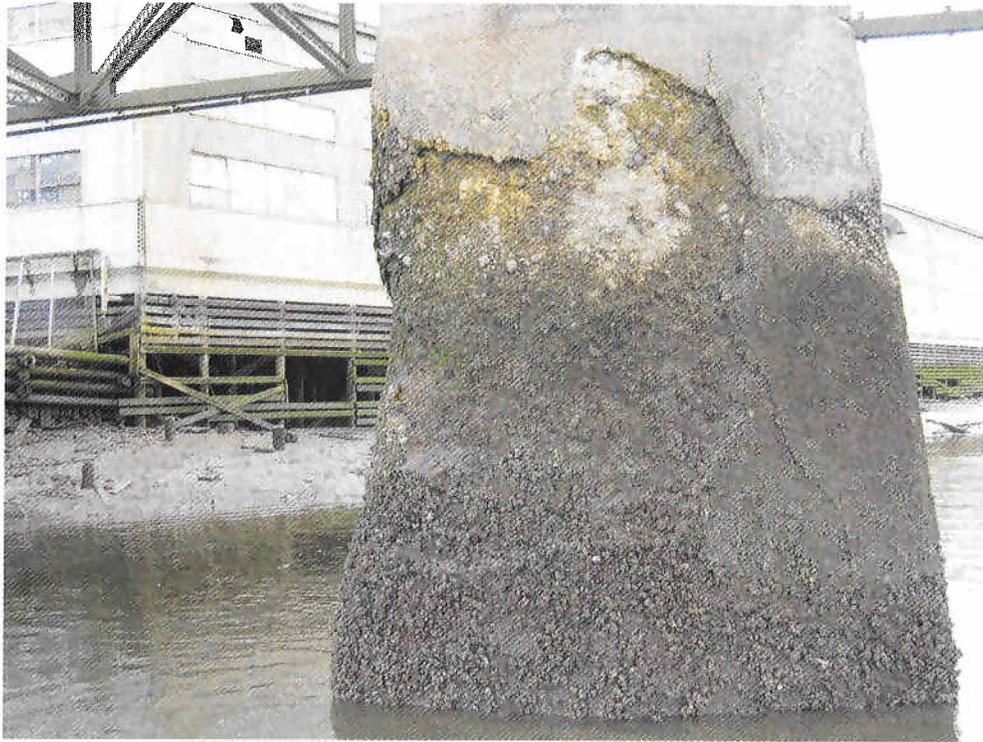
undermining of seal noted. The West face of Column A has abraded 3" deep in the intertidal zone. Concrete delaminations and spalls are present on the West face of Column B.

Photograph 7 : Column A section loss, West face, in intertidal zone to mudline at Pier 1 North.

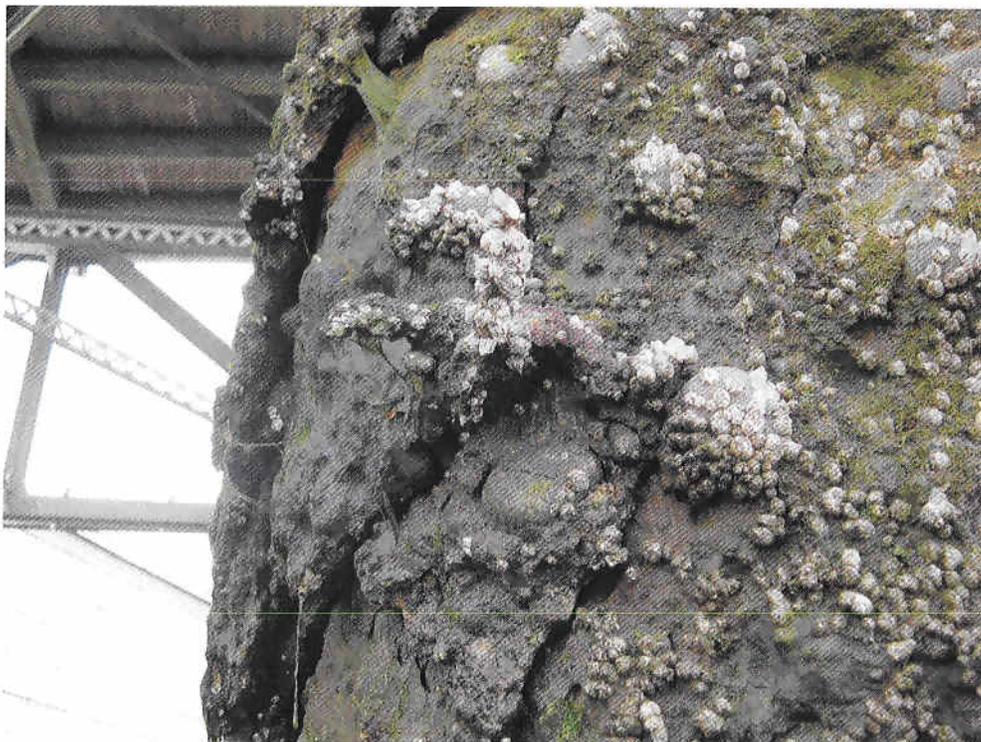
Photograph 8 : Close up view of concrete at Column A West face Pier 1 North.

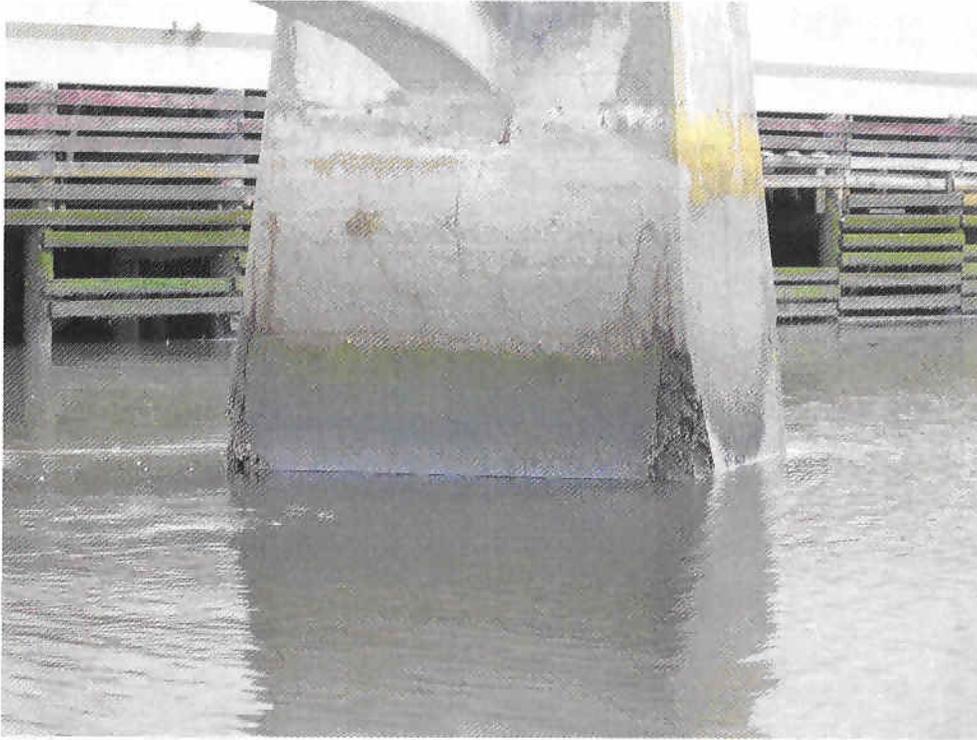
Photograph 9 : Corner spalls and concrete delaminations on the West face of Column B Pier 1 North.

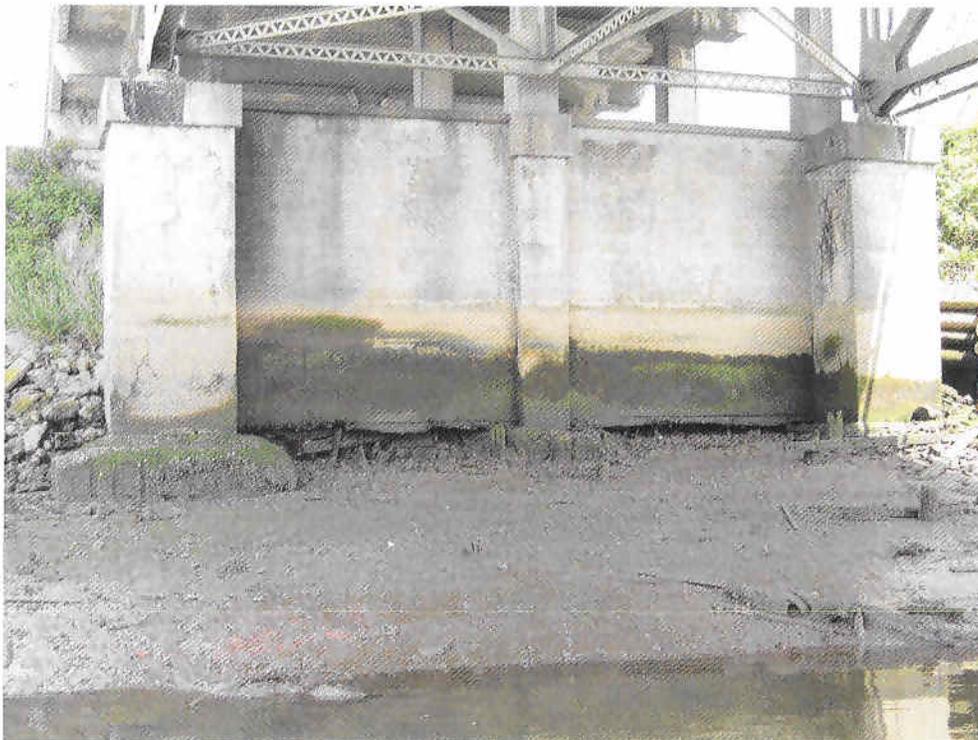
A fathometric survey of the channel was completed May 10, 2005. In comparison to data in the December 2003 report, the water depths vary at the bascule pier locations but the main channel has remained static. This is due to the nature of the silty bottom and varying current of the Duwamish River as well as dredging operations. No undermining of structural foundation components was noted. The northwest corner of the South Bascule Pier is aggrading with silt equal to the MLLW line. At the southwest corner of the North Bascule Pier, the footing is exposed approximately 1' due to degradation of the channel bottom. Also, Pier 2 North Column A footing is exposed (see photo # 10).

Photograph 10 : South face of Pier 2 North. Exposed footing at Column A with undermining of the pier wall.

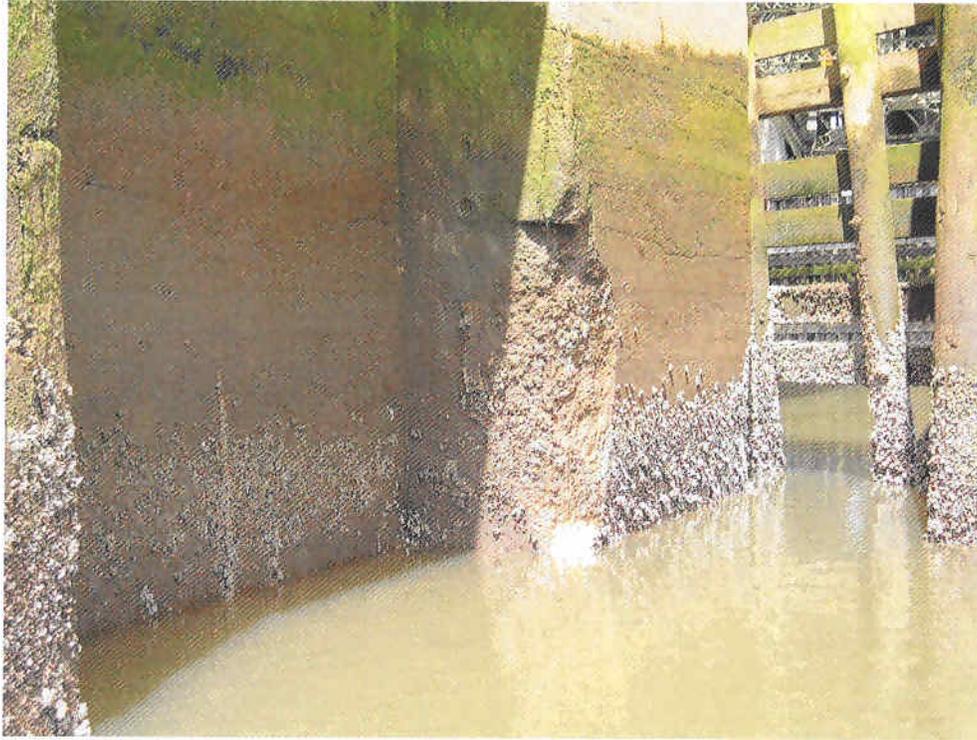
Photograph 11 : Concrete spall East face of South Bascule Pier.

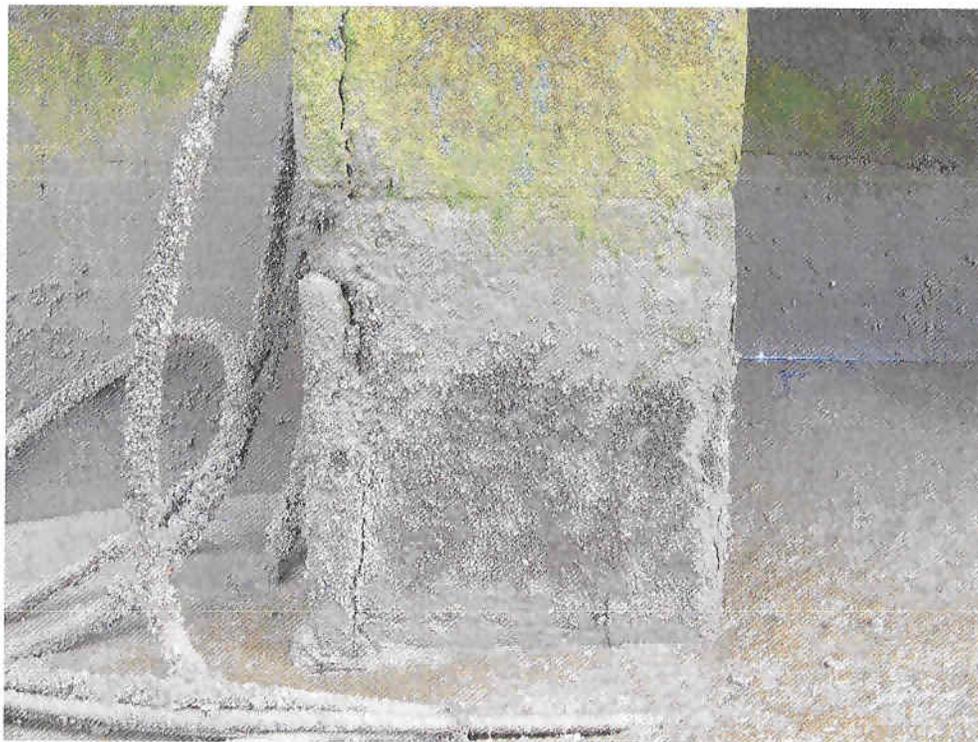
Photograph 12 : Delaminations at Northwest corner of South Bascule Pier.

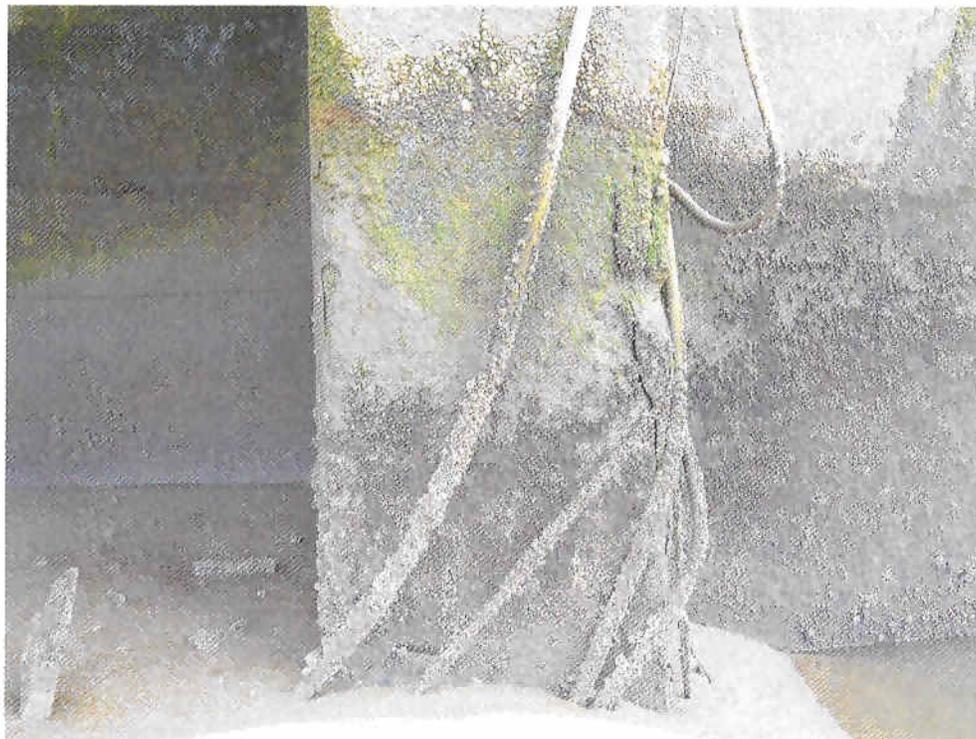
Photograph 13 : Delaminations at Southwest corner of South Bascule Pier.

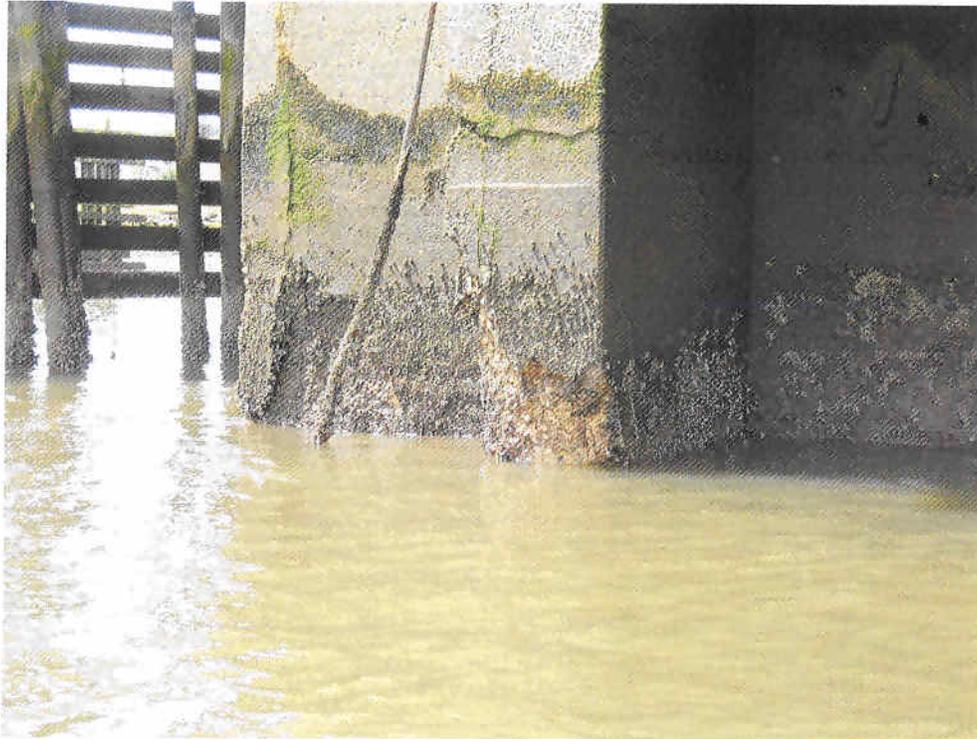
North Bascule Pier, the concrete deterioration is similar to the South Bascule Pier. Corner spalls and delaminations are present as well as a 4' long exposed piece of rebar at the northwest corner (photo 16). Corner delaminations, abrasion, and leaching cracks on East face (photos 14 & 15).
	4	West face of Column A Pier 1 South has a 2-1/2' long x 1' wide x 2" deep area of section loss (photo 1). Northeast corner of Column A Pier 1 South has a 4' long delamination to the mudline and deteriorating concrete on the East face (photo 2 & 3). East face of Column B Pier 1 South there is a 2' long x 1' wide x 2" deep spall at the mudline (photo 4).
		West face of Column A Pier 1 North has abraded 3" deep in the intertidal zone (photos 7 & 8). Concrete delaminations and spalls are present on the West face of Column B Pier 1 North (photo 9).
	8	North Bascule Pier: approximately 1' of exposed footing at the southwest corner. Footing exposure is prevalent at Pier 1 North. Column A footing and seal is exposed 5' along the East face of the Pier and 8' along the West face of the Pier. Column B footing and seal is exposed 4' along the East face of the Pier and 1-1/2' along the West face of the Pier.

Photograph 15 : Concrete section loss at Southeast corner of North Bascule Pier.

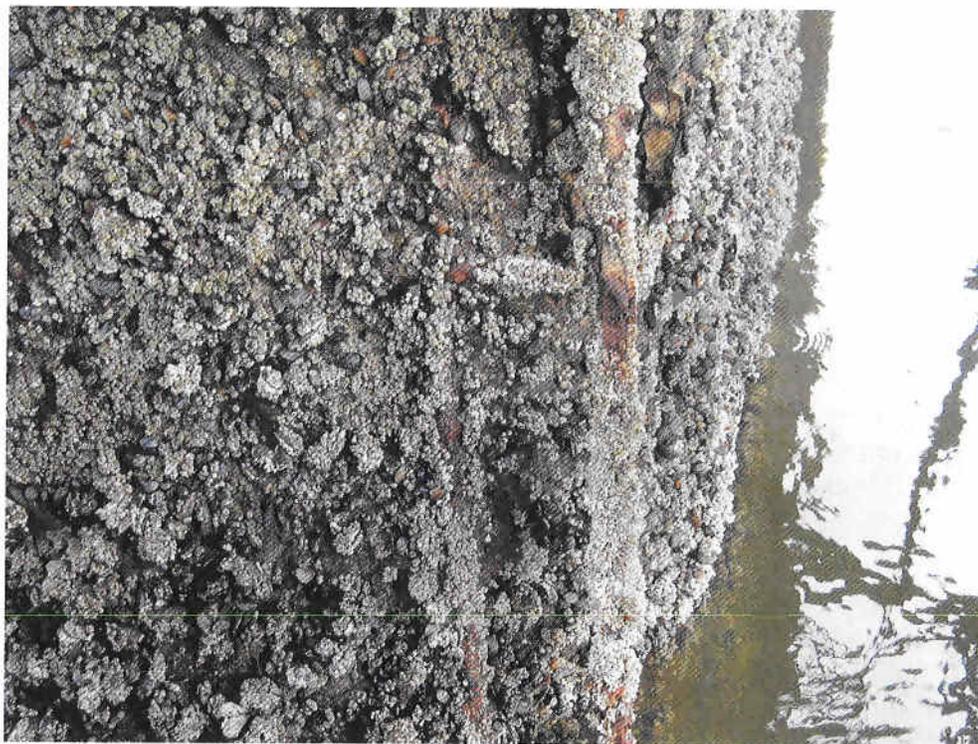
Photograph 16 : Exposed longitudinal reinforcing at Northwest corner of North Bascule Pier.
