**Washington State  
Department of Transportation**

**UNDERWATER INSPECTION REPORT**

**SOUTH PARK BRIDGE - 14TH AVE. OVER THE DUWAMISH RIVER**

**BRIDGE NO. 3179**

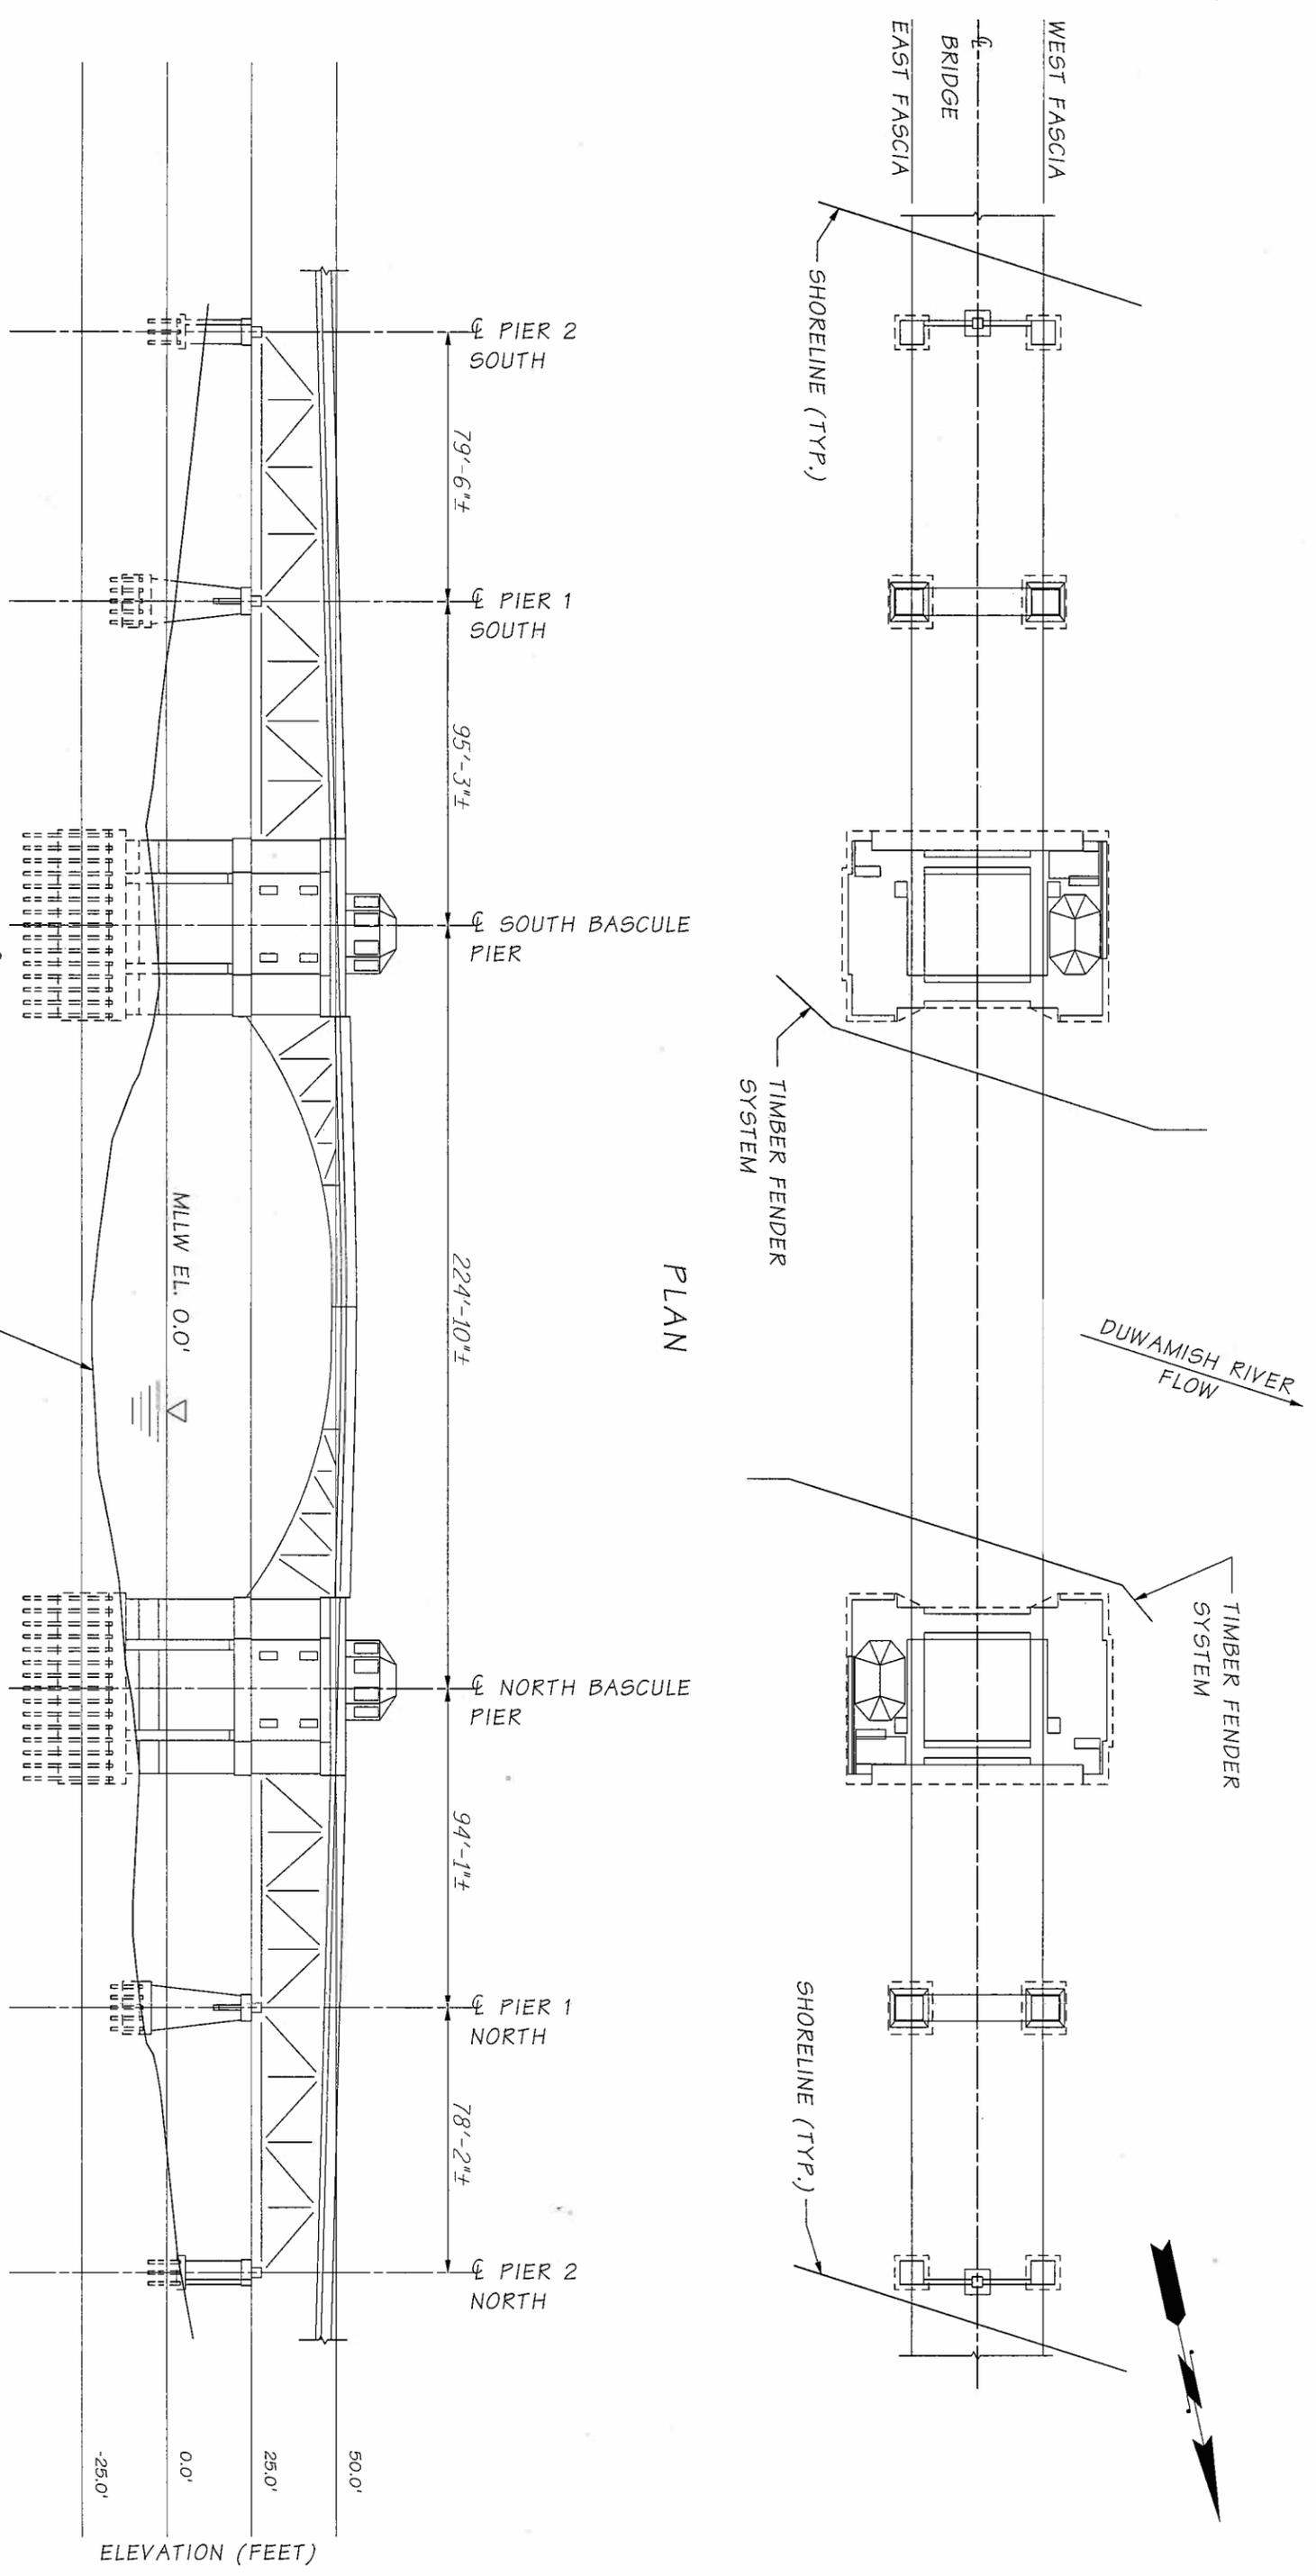
3179 SOUTH PARK BRIDGE  
UNDERWATER INSPECTION  
SOUTH PIERS

- TYPICAL INSPECTION NOTES:
1. CONCRETE ABRASION IN INTERTIDAL ZONE AT ALL PIER LOCATIONS.
  2. VERTICAL AND TRANSVERSE LEACHING CRACKS AT ALL PIER LOCATIONS.
  3. 4" DIAM. TO 8" DIAM. CONCRETE SPALLS UNDERWATER IN BASCULE PIERS (PHOTO 17).

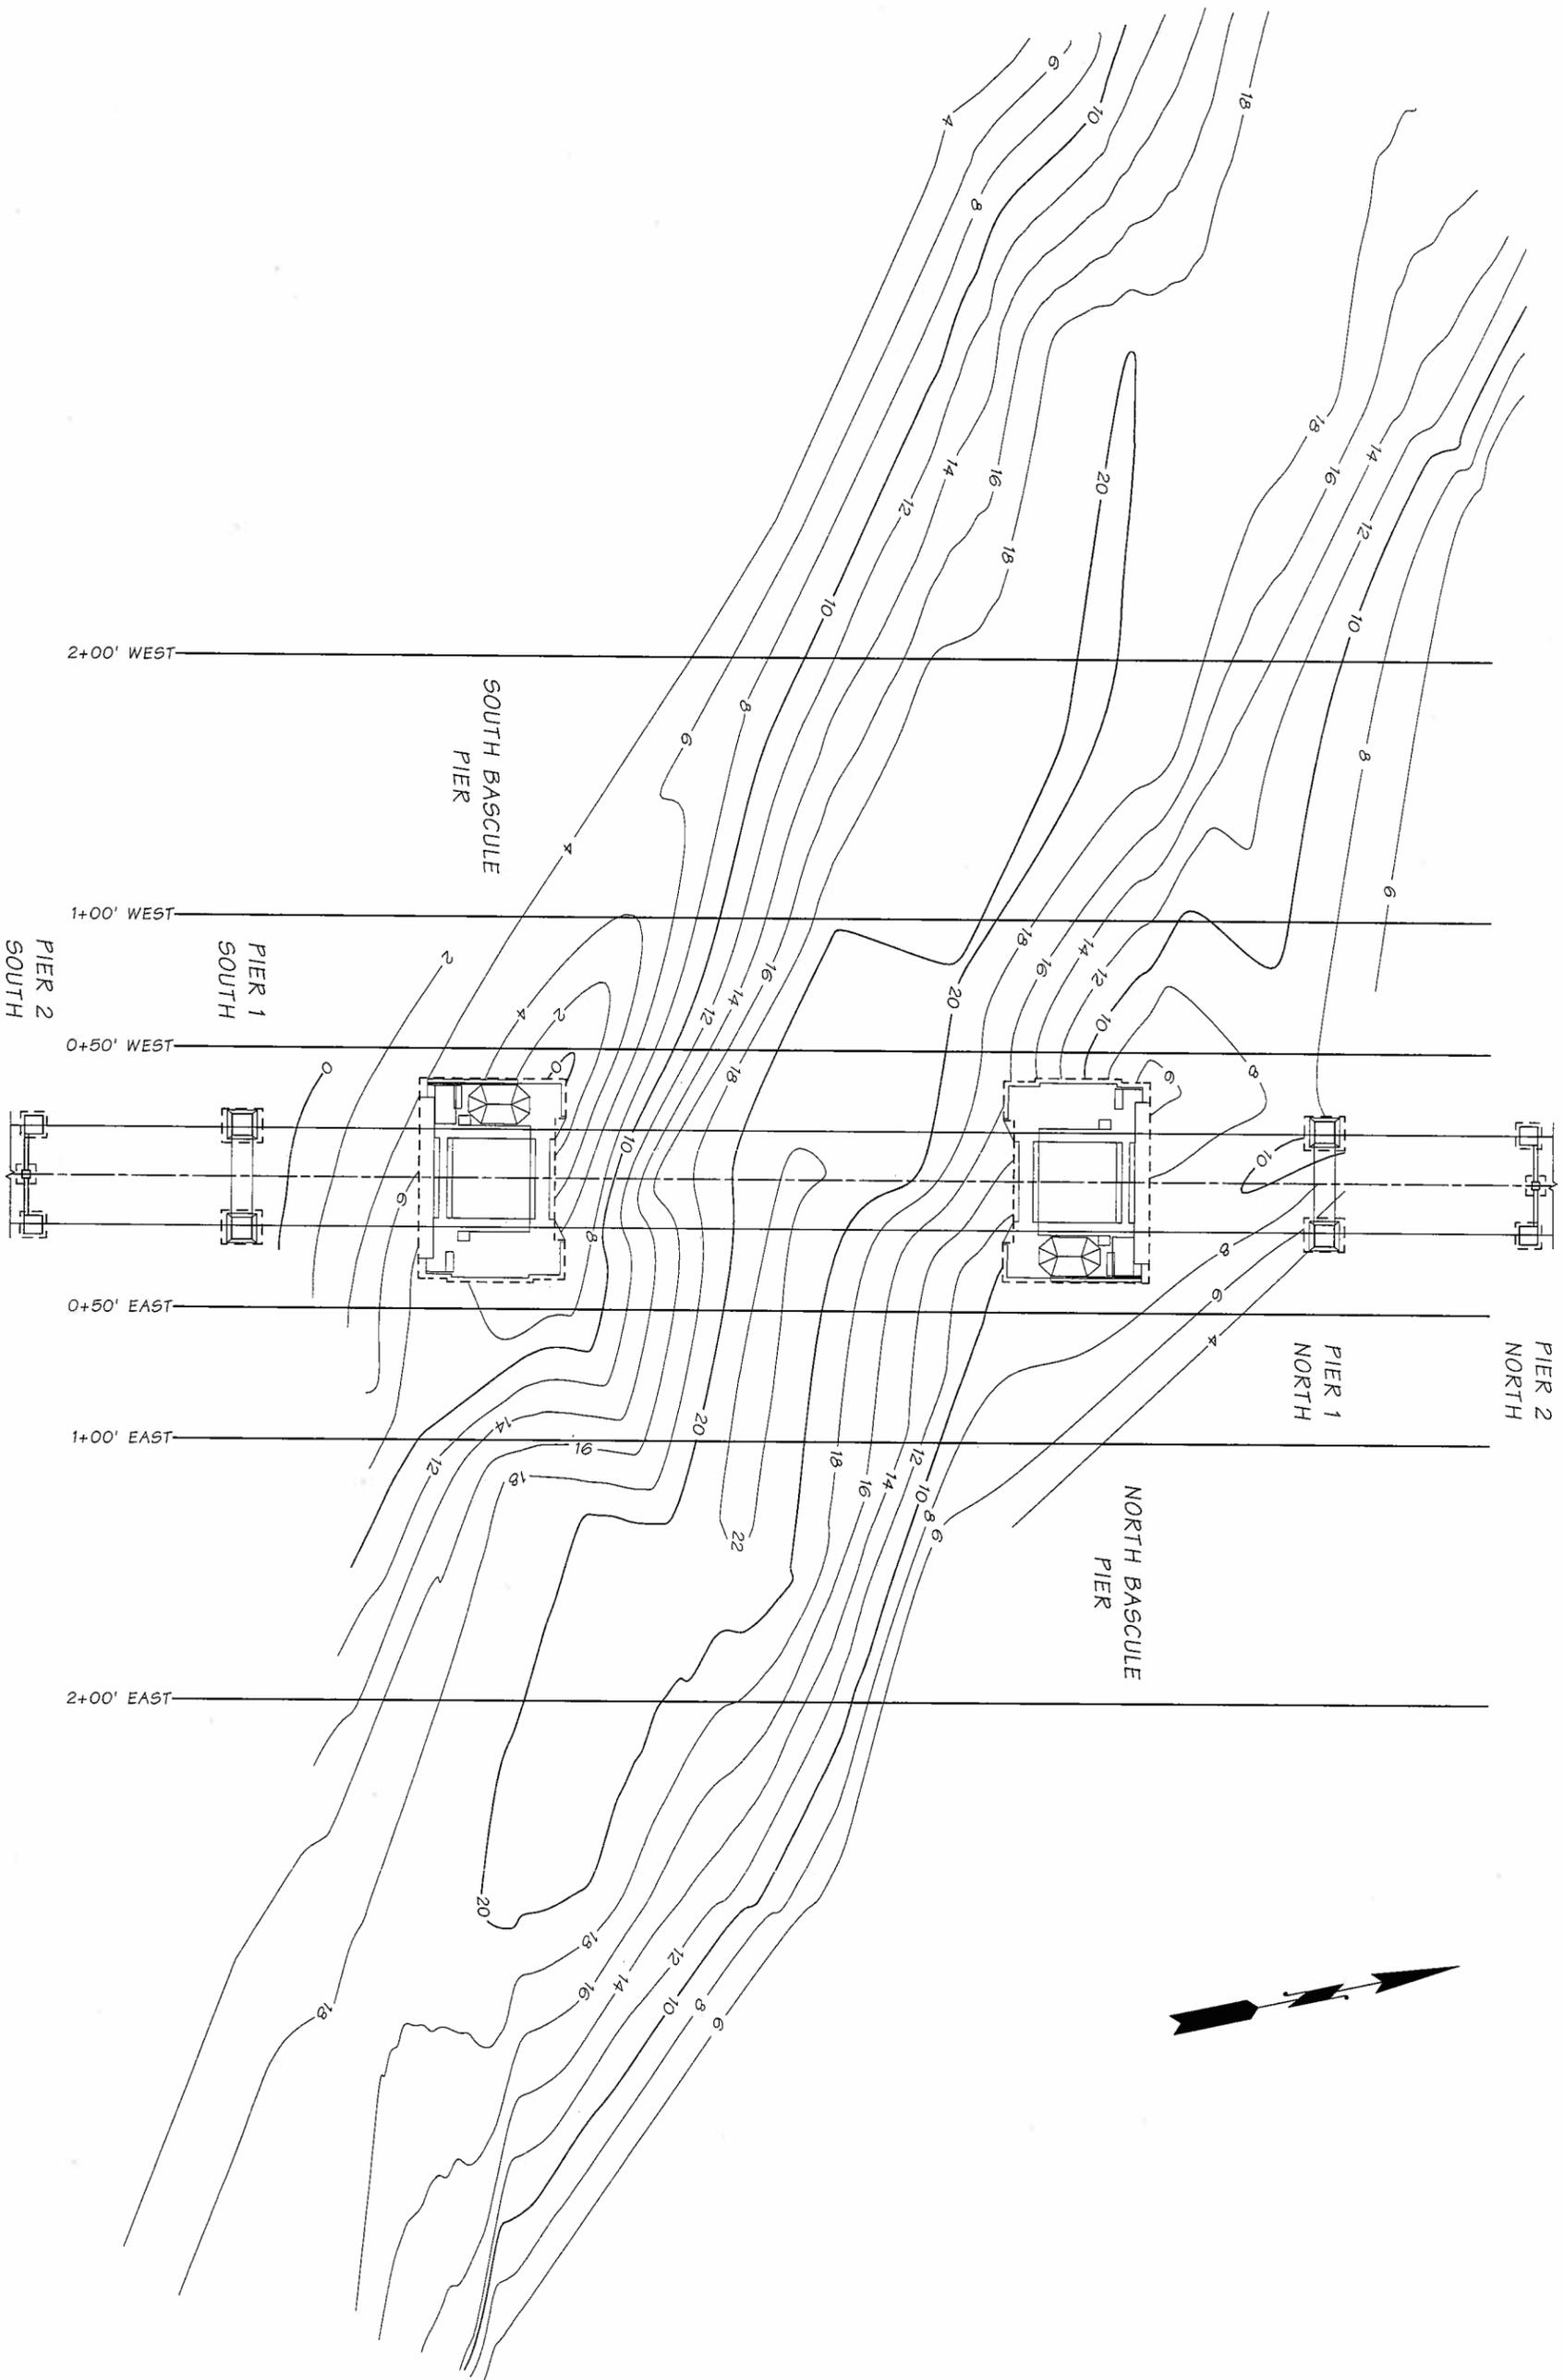
SHEET NO. 3  
3  
4  
SHEETS

- TYPICAL INSPECTION NOTES:
1. CONCRETE ABRASION IN INTERTIDAL ZONE AT ALL PIER LOCATIONS.
  2. VERTICAL AND TRANSVERSE LEACHING CRACKS AT ALL PIER LOCATIONS.
  3. 4" DIAM. TO 8" DIAM. CONCRETE SPALLS UNDERWATER IN BASCULE PIERS (PHOTO 17).
